ALLSTAR TECHNICAL NOTE

Product: Challenger S (AC9300) and Challenger GL (AC9500)

Subject: Operator Does Not Run Using Radio Control

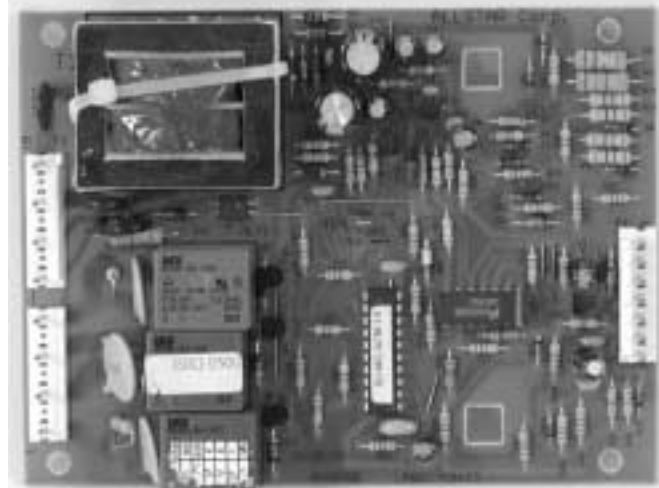
We have had some reports from customers that sometime after installation, the Challenger Operator stops working from the radio controls however continues to work properly from the wall button. Only a small number of operators have exhibited this problem. A picture of the subject control board is below.

Field returns and lab testing indicated that a component on the control board was being damaged. Under certain conditions, electrical noise from thunder storms, electrical appliances and other inductive loads could enter the control circuit, by way of the pushbutton wires, and damage electrical components on the control board. Further testing showed this problem could be virtually eliminated by upgrading a component on the control board. When tested in the lab, the control board with the new component withstood 3 times more voltage than the control board using the old component.

All products, including finished operators, replacement boards and warranty repairs, produced after June 27th will have the upgraded component installed in the control board.

NOTE: Low voltage wires used for pushbuttons and photobeams should never be installed next to high-voltage wires. Typically they should be routed 8-12 inches from any high-voltage wires. Other regulations may apply. Always check local building codes for current requirements.
